# Summary report of tested materials

D1.4

# RecHycle

Oct 2024

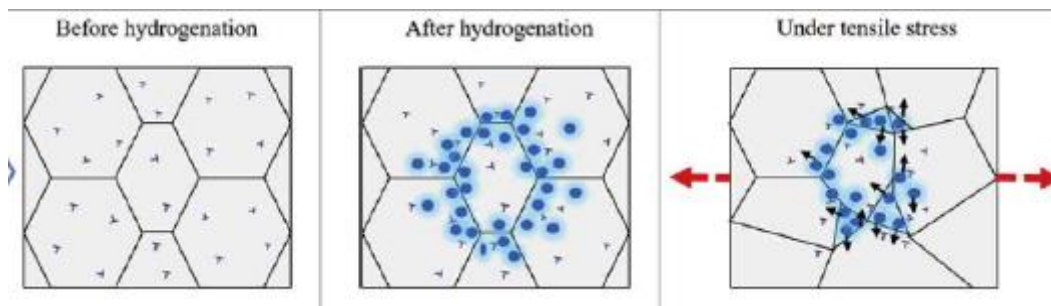
Figure 1. The mechanism of Hydrogen infiltration<sup>5</sup>.

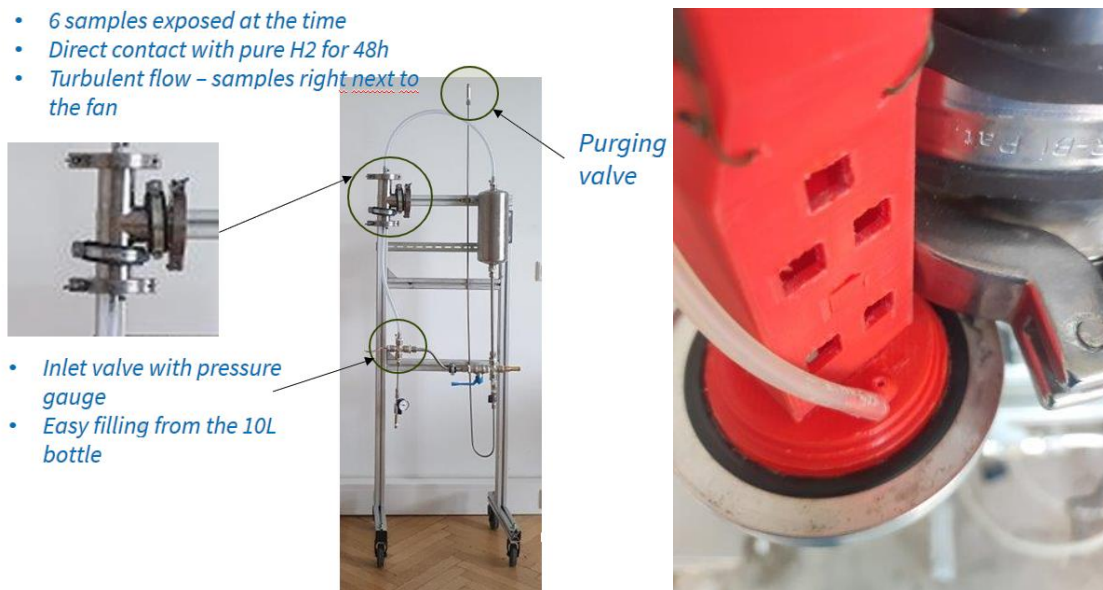
Figure 2. Hydrogenisation (H<sub>2</sub>-O) setup (left) and the sample holder (right).

The setup consists of a Hydrogen deposit (vol: 2L), which is directly connected to a 10L bottle of Hydrogen, with an one-direction valve, to ensure the easy filling of the circuit, but prevent the loss of the gas. The filling for each testing is done until the pressure in the deposit is between 4.5 and 5 bar. The circuit ensures the flow of the Hydrogen by a slight over pressure (150 mbar) in the sample holder and a fan which is installed right at the entrance of the sample holder. The sample holder lodges 6

transversally positioned samples, which are exposed to a laminar or turbulent regime, according to the settings of the fan (in our case, it was set to turbulent, to promote more Hydrogen contact with the sample). The system was tested to withstand more than 60h, until the pressure reaches 1.5 bar (the pressure below this value would create conditions for the entrance of air and possible deflagration). After 48h of testing, it normally reaches 1.7-1.8 bar, sometimes even remains at 2.0 bar (depending on the atmospheric pressure of the surrounding). Hence, the end of **the test was set as 48h after the start** upon this test results, but also for three more reasons:

The metal samples were mounted into the sample holder shown in Figure 2 right. Pure hydrogen with turbulent flow conditions of approx. 10 m/s circulates through the device with a pressure starting at >4 bar. The samples are mounted directly behind the ventilation system in order to establish a turbulent flow regime. The sensor system purchased with the device did not correctly show the pressure and had an error of  $\pm 60\%$  of the value obtained manually from the pressure gauge. Unfortunately, there was no time within the project to return the device for a proper sensor reset and the device was used as it was and the values were obtained manually from the pressure gauge.

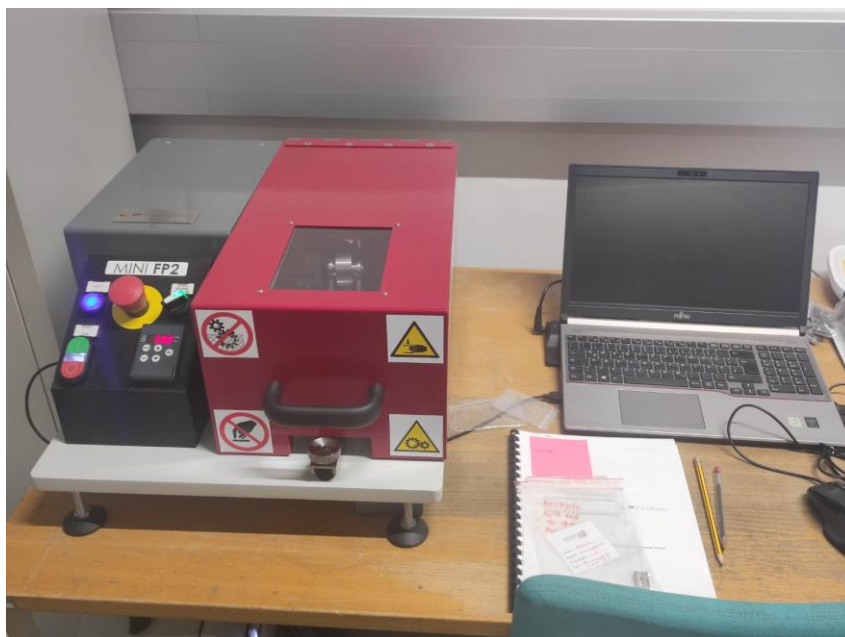
Figure 3. Mini FP2 testing equipment.

This compact equipment is normally used to evaluate dynamic properties of small samples, which have been manufactured using different process conditions (casting, welding, 3d printing). So, during the process development, it is used to qualitatively ensure which process conditions can give better dynamic performance of the obtained material. Without preclusion, it can be used for *any comparative study*: post processing, chemical exposition of samples – whenever the dynamic properties of the material are a revealing factor – in this case it is, since the embrittlement reduces the tenacity of material and reduces its dynamic performance.

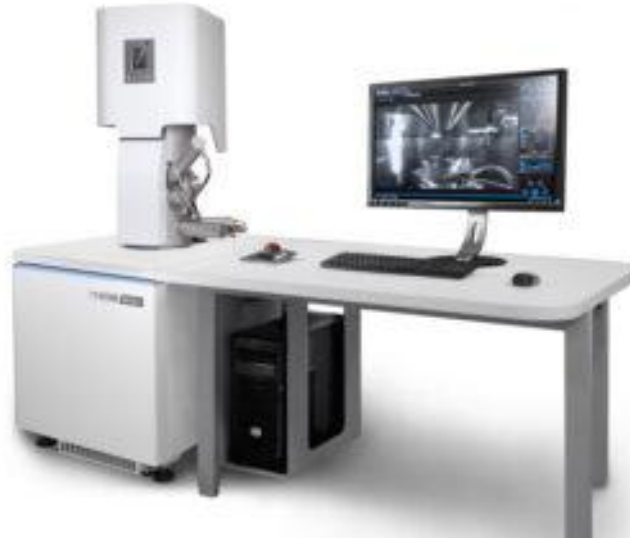
To this aim REM-TESCAN equipment, based on Scanning Electron Microscopy (SEM) at JOA has been widely used. The following figure shows the equipment. SEM is a well-known non-destructive technique that uses an electron beam probe to analyse samples surface down to nano-scale. The SEM produce high magnification images with high resolution, a feature of which makes them suitable tools for a wide range of applications in numerous fields of science and industry, such as the comparative analysis of the microstructural states. The one at JOA is also equipped with the EDX, so, to certain extent and precision, the chemical composition can be also evaluated.

Figure 4. TESCAN's SEM equipment.

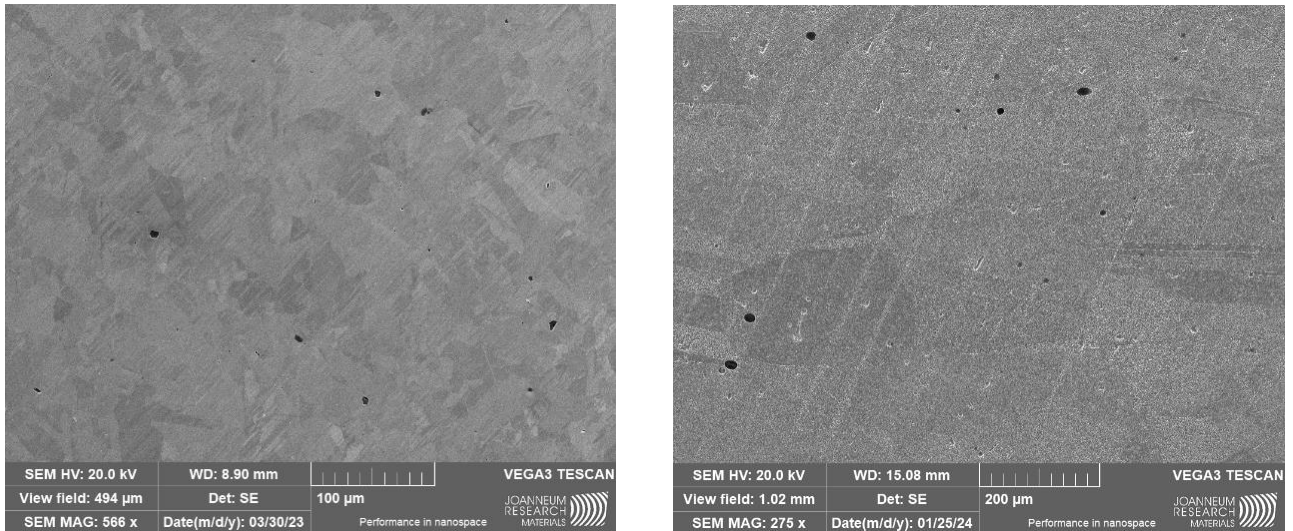
- Arcelor Mittal blow lance: grain size: 20 – 80  $\mu\text{m}$ ,  $\gamma$ -matrix; No  $\gamma'$  or  $\gamma''$  phase or  $\delta$  phase and small amount of inclusions
- Good Fellow foil: grain size: 100- 200  $\mu\text{m}$ ,  $\gamma$ -matrix; No  $\gamma'$  or  $\gamma''$  phase or  $\delta$  phase and small amount of inclusions

Figure 5: The microstructure overview of the as-received Material 1 pipe of Arcelor Mittal (left) and the Material 1 plate from Good Fellow (right)

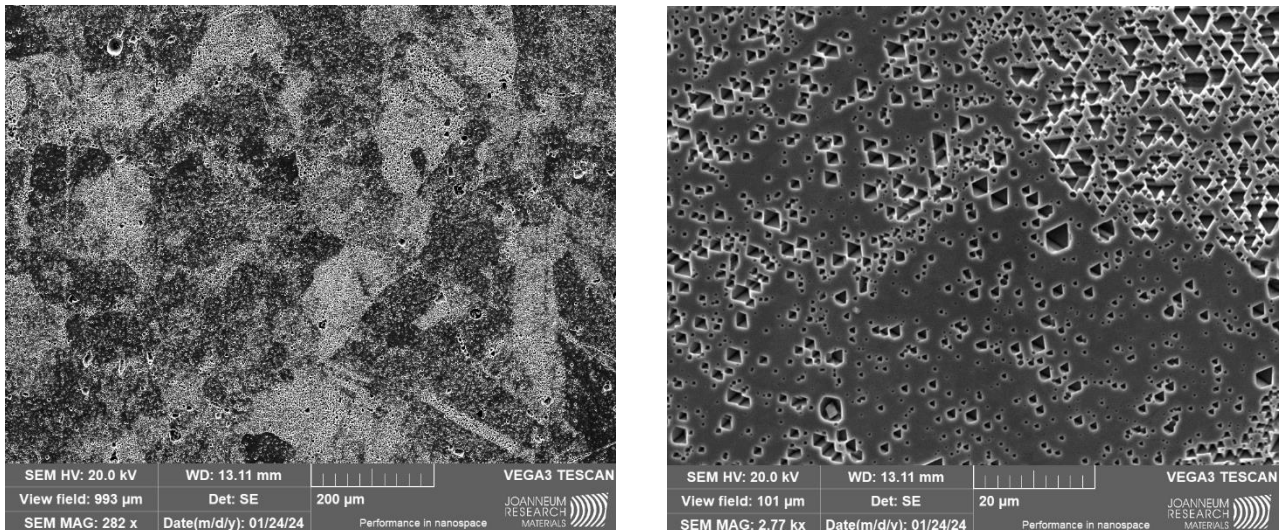
Figure 6: The microstructure of the as-received Material 1 plate depicting the pores and cavities at the surface

The cavities and pores were analysed with EDX and revealed the same chemical composition as the rest of the material, indicating that the pores were formed during the manufacturing process. The cross sectional area of the material was analysed next, to see if the cavities and pores are only surface prone, or if they also are found within the bulk of the material.

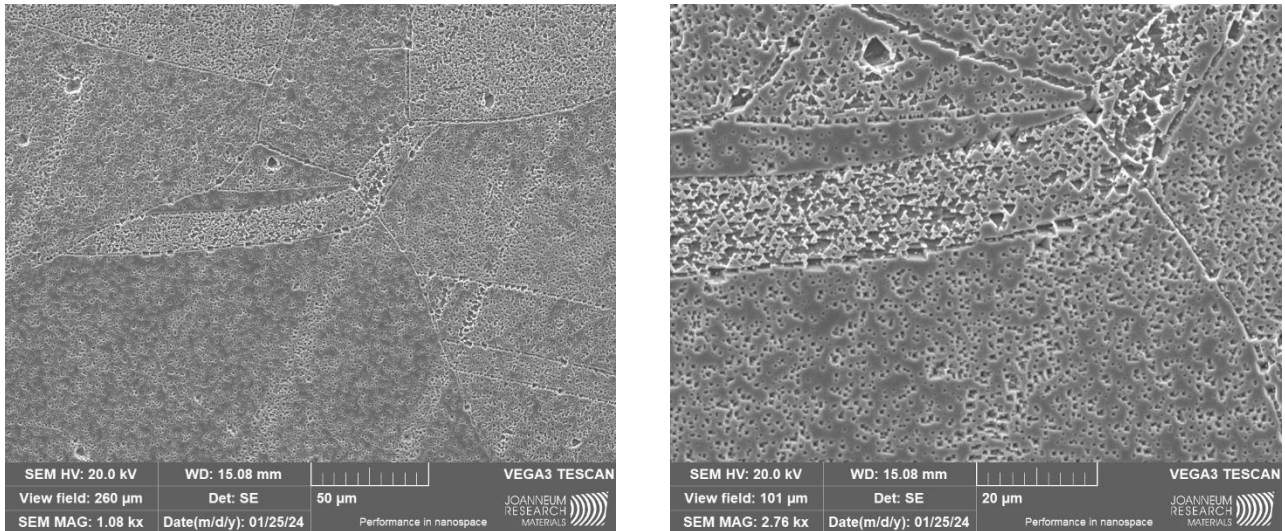
*Figure 7: The microstructure of the as-received Material 1 plate depicting the pores and cavities from the cross section of the material*

The cavities and pores are present throughout the whole bulk of the material (Figure 7 left and right). Nonetheless, the material was still used for hydrogen charging even though pores and cavities are present mainly for two reasons:

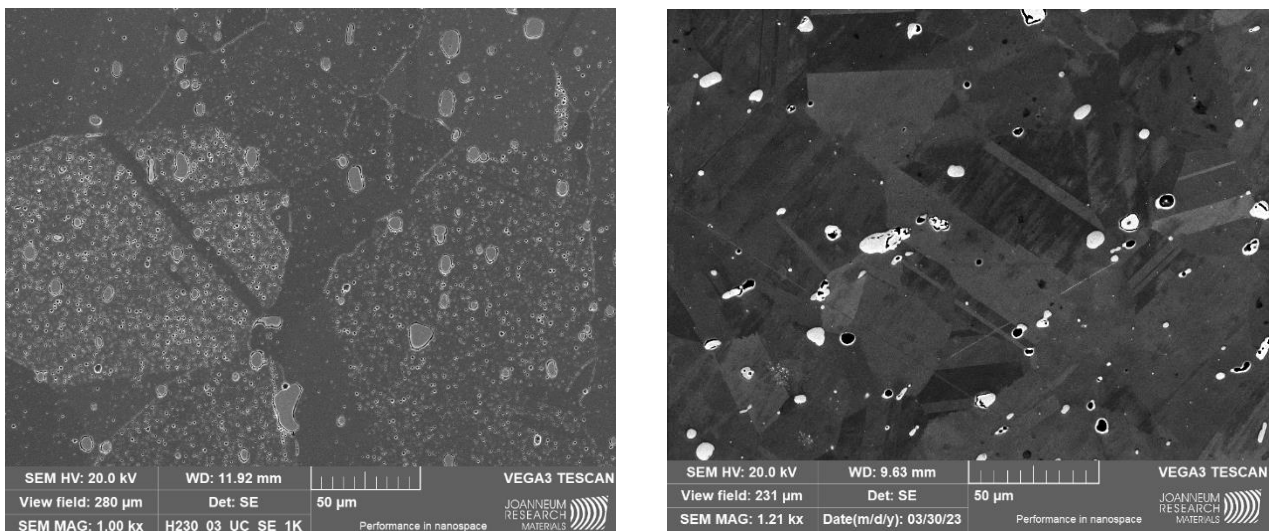
*Figure 8: Haynes Alloy from Good Fellow Rod (left) vs. the Material 2 pipe from Arcelor Mittal (right)*

The Goodfellow rod shows more tungsten particles within certain grains, but overall the tungsten percentage is the same as within the material of Arcelor Mittal, which was proven by EDX analysis. The grains of the Goodfellow rod show bigger grains which lie above  $>100\ \mu\text{m}$ , whereas the grains of Arcelor Mittal are smaller. The tungsten particles within the Arcelor Mittal specimen are more scattered throughout the material and are not centred along the grains and within the grains. Even though the highly centred tungsten particles could cause HE when charged this is not the case as shown in this further study, therefore we can conclude that the material of Arcelor Mittal should also withstand the conditions of hydrogen charging for 48h.

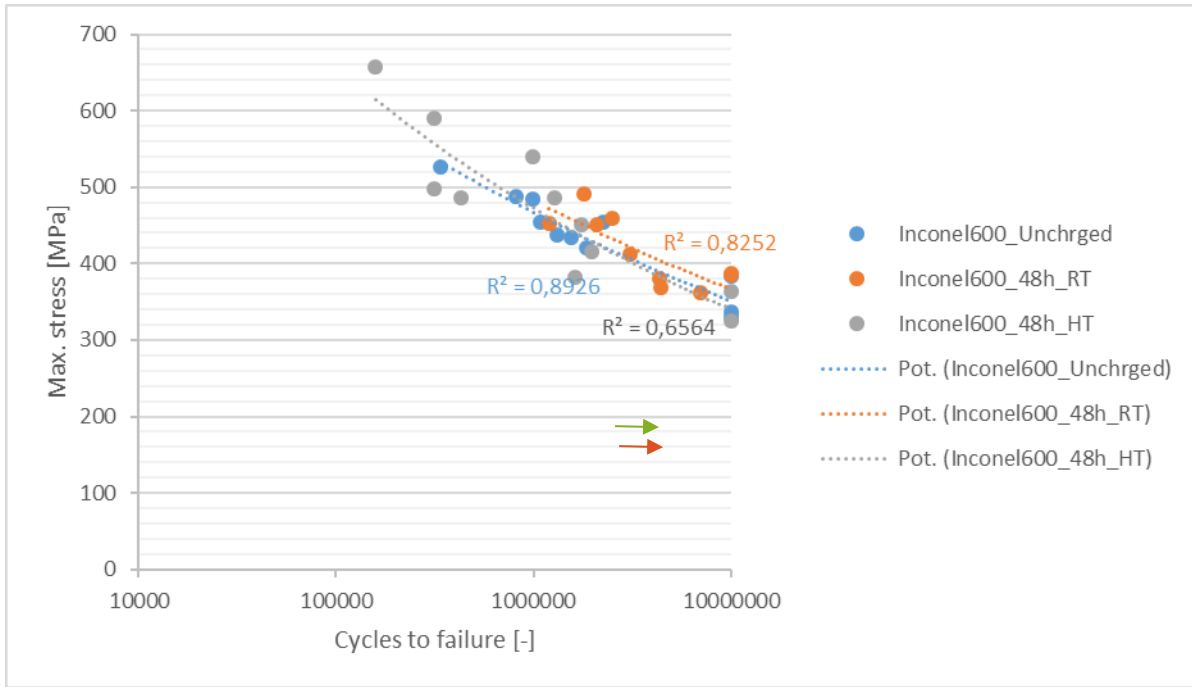
The following figure shows the comparison of *the Wöhler curves of Material 1 samples uncharged, charged at RT and charged at HT*. The potential curves have been calculated using the raw data values and extrapolating a potential model which fits best to the data obtained by the measurement. *Three different f(x) values were obtained through the power law fit (f(x) = y0 + A \* x<sup>pow</sup>), for all three conditions (the uncharged, RT charged and HT charged) and then used to calculate a mean corrected value for 500 MPa, 450 MPa and 400 MPa loads.*

Figure 9: Wöhlercurve of Material 1 Alloy uncharged vs. Material 1 Alloy 48h charged at RT vs charged at HT

The values selection followed the literature. Lima et al<sup>13</sup> did the testing of Inconel 625 with the range of loads 350 and 550MPa, starting at the mid-value of 450MPa, so for Material 1 we followed the same range.

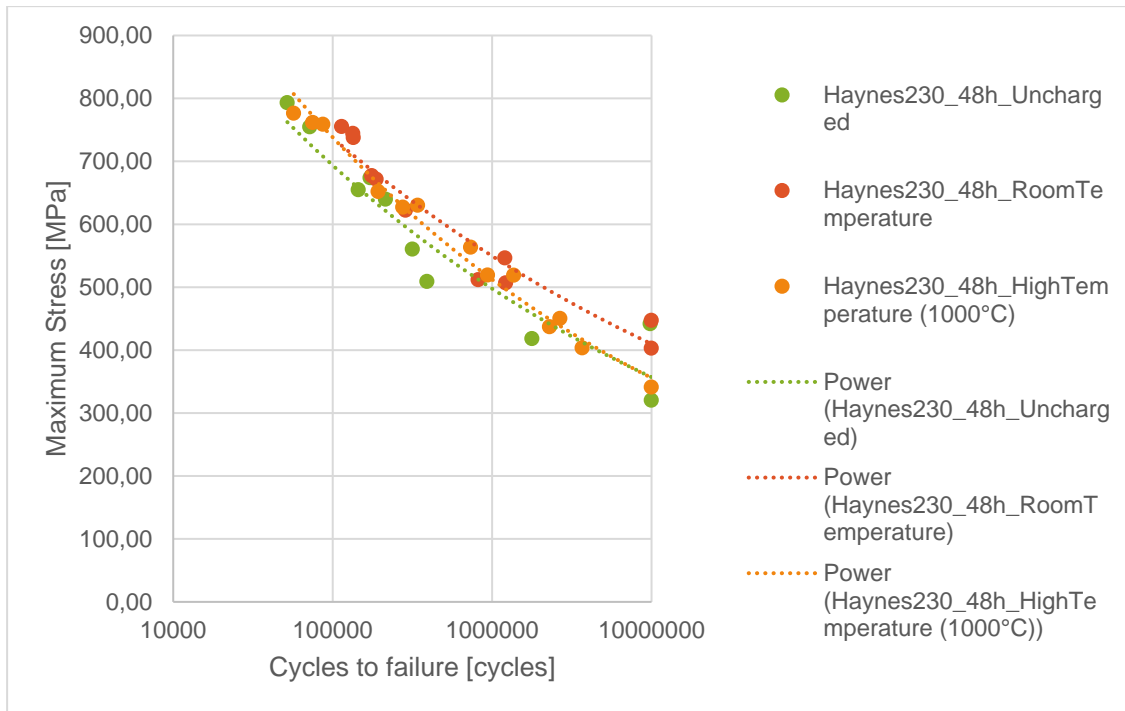
The Wöhler curve comparison for Material 2 is shown next, followed by the calculation of the HE index, in the same manner like with Material 1.

Figure 10. Wöhler curve of uncharged, RT charged and HT charged Material 2 alloy specimens, with the potential curves extrapolated upon the raw data.

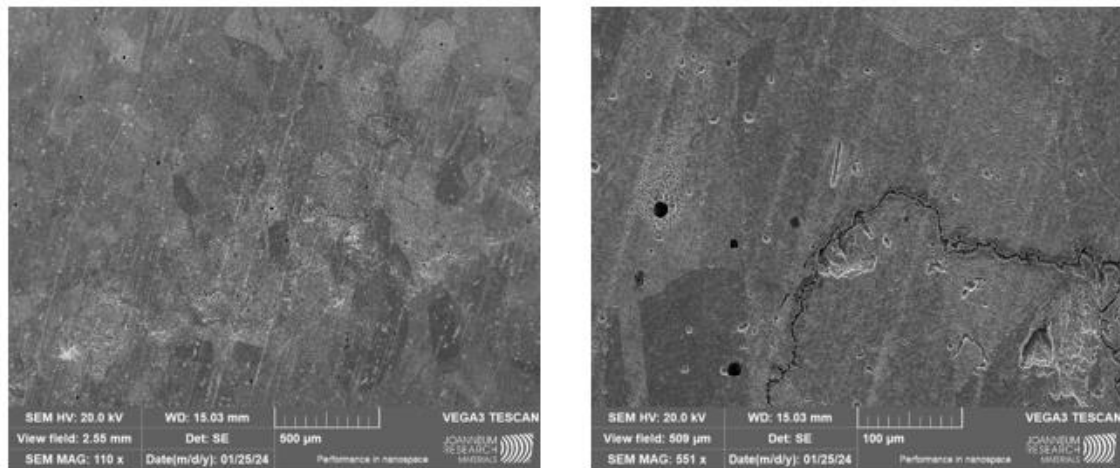
The *RT charged specimen* were first observed under the SEM after being used in fatigue testing. The following cracks, which can be seen within Figure 11, are the result of the fatigue measurements. However, the underlying microstructure did not change significantly after the charging, in comparison to the original Material 1 microstructure. The BSE images indicate an equiaxed microstructure and the specimen have a relatively uncomplicated microstructural phase namely the  $\gamma$  phase with Cr-rich Carbides and the absence of the  $\gamma'$  forming elements [Ref]. The grain size  $>50 \mu\text{m}$ . The grain size is also important for the hydrogen embrittlement, as smaller grain sizes have a higher propensity for cracking as stated by Fabien Leonard<sup>15</sup>. The grains are quite nicely visible and the grain boundaries can be seen at magnifications of  $20 \mu\text{m}$ . The carbides do not play a significant role as there are not many scattered within the material. Therefore, the absence of the intergranular and intragranular carbides could be a reason why the material is not affected by the hydrogen infiltration.

Figure 11: The microstructure of the 48 h RT hydrogen charged Material 1 plate depicting the pores and cavities from the cross section of the material. Left: Microstructure does not change, No evident hydrides or other formations between the grains. Right: Crack that formed through fatigue testing.

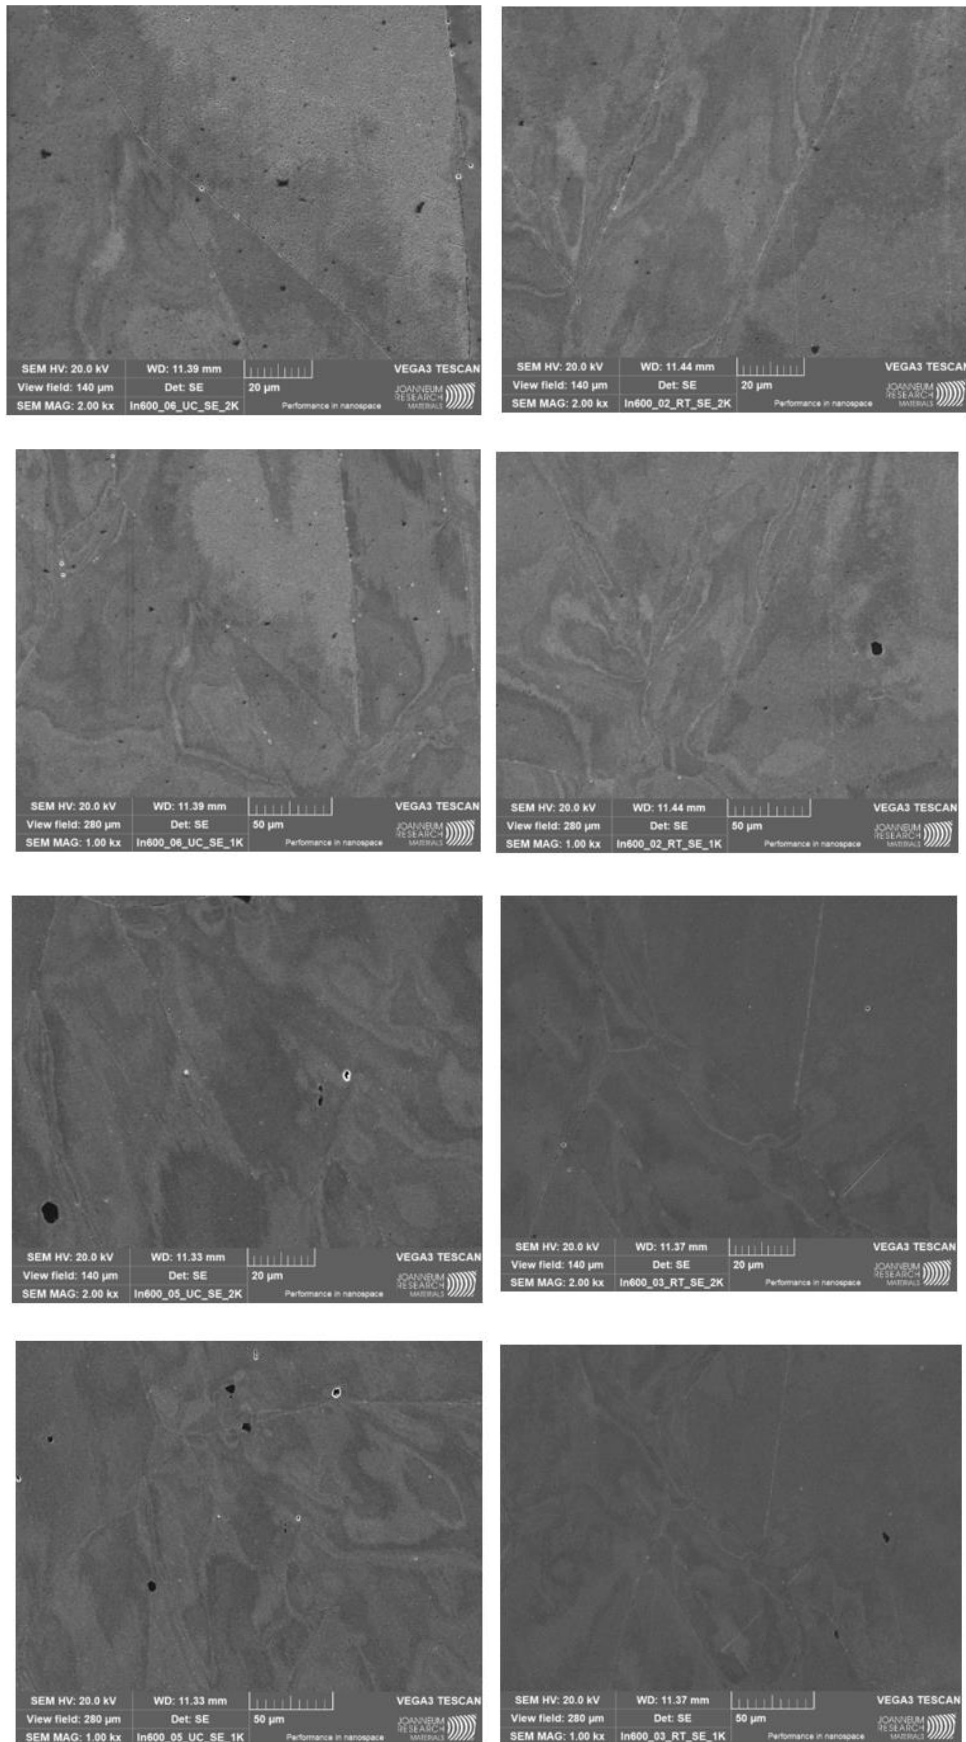
The different cross sectional areas of a different RT charged specimen were analysed to ensure no crack formed in the presence of hydrogen. The following figures are from different specimens/sections, where no cracks were observed and the comparison of hydrogen – charged to uncharged specimen show no signs of hydrogen embrittlement. However, the pores from the manufacturing process have been continuously observed.

Figure 12: SEM images of different sections/samples to show the absence of the Hydrogen induced cracks and microstructural changes in RT charged samples

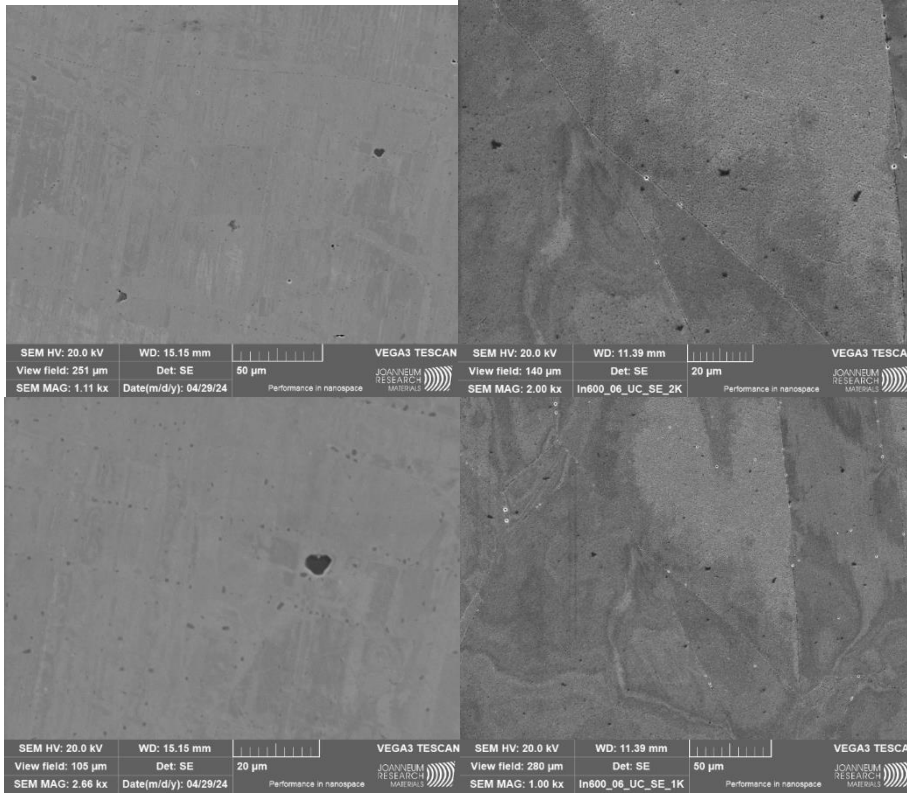
High Temperature (1000°C) hydrogen charged specimen are shown below. They were also investigated and the results are presented in the images below. The grains do not change in size due to the high temperature which was applied during the process, furthermore the carbides within the material do not deteriorate within the material and no cracks or pores can be found near the grain boundaries, nor at the carbides scattered throughout the material. If hydrogen embrittlement occurs, it would most likely occur at the carbide inclusions as these are defects within the material. This however does is not the case for this material.

Figure 13: SEM images of different sections/samples to show the absence of the Hydrogen induced cracks and microstructural changes in HT charged samples (Sample 1).

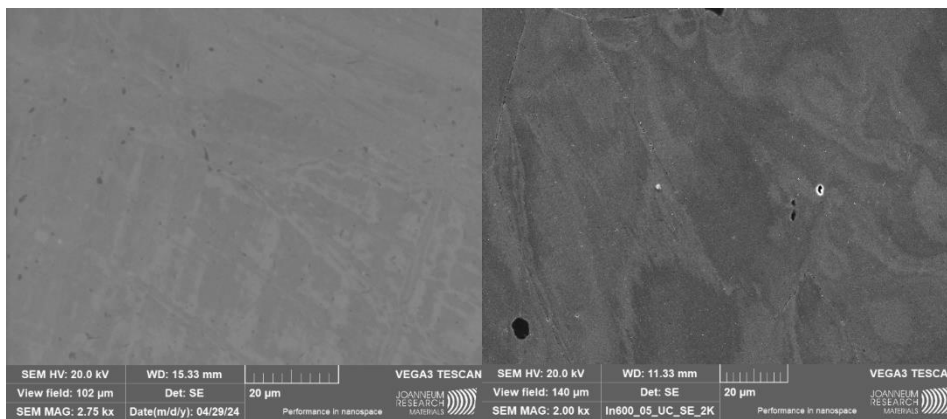
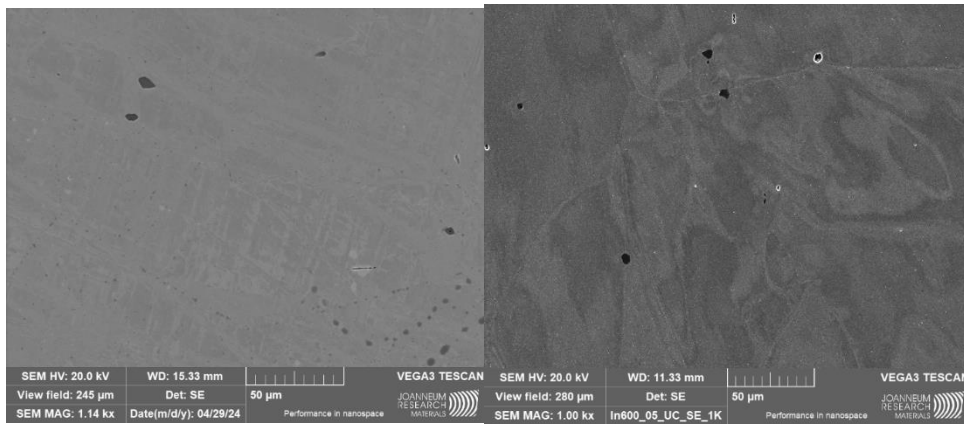
Figure 14: SEM images of different sections/samples to show the absence of the Hydrogen induced cracks and microstructural changes in HT charged samples (Sample 2)

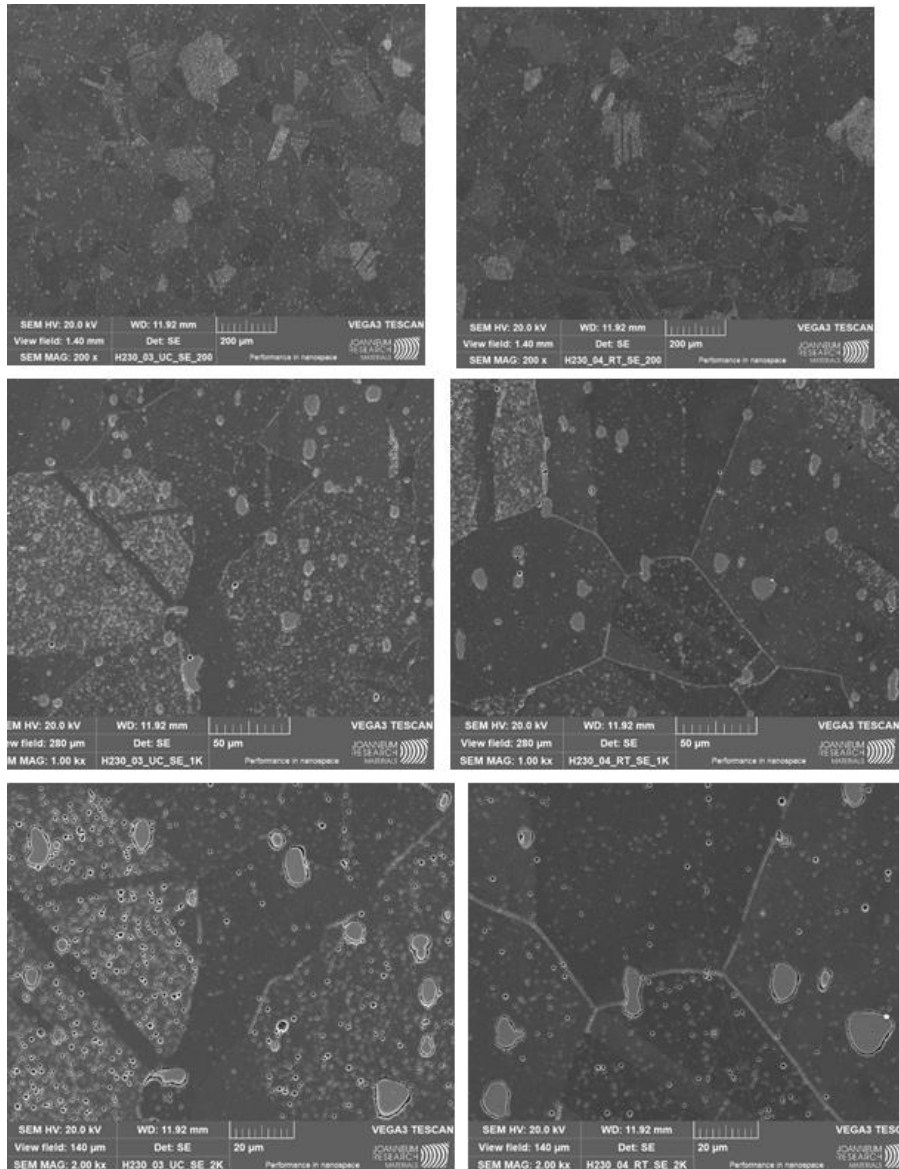
Figure 15. Microstructural analysis of the Material 2, sample 1 – left charged at RT, right uncharged, three different sections.

The grain size of the uncharged Haynes alloy varies from 50 – 200  $\mu\text{m}$ , whereas the number of grains above 200  $\mu\text{m}$  is relatively low. This phenomena does not change when charging the material with hydrogen. The FCC-matrix grains show quite well defined grain boundaries, as seen in figures below (*right uncharged and left charged 48 h*). Tungsten rich precipitates are evenly scattered throughout the material both in the uncharged and charged specimen. The precipitates and matrix grains do not change in size or deform during the process of hydrogenation. No crack or pores form through the charging process, which is in accordance with the fatigue behavior.

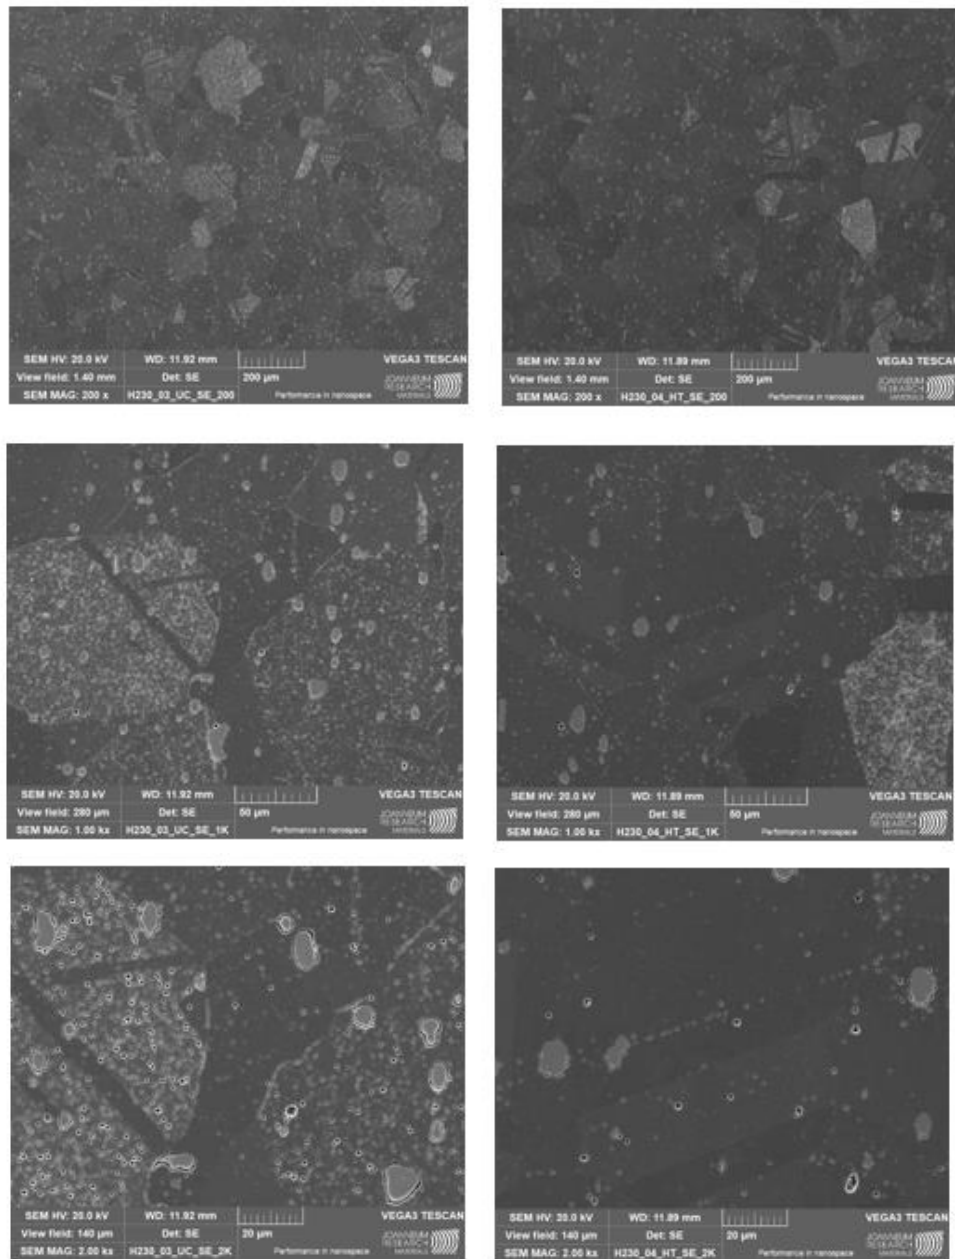
The specimen charged at elevated temperatures, above 1000  $^{\circ}\text{C}$ , also show no signs of hydrogen embrittlement within the SEM images. The grain sizes do not change evidently and more important no pores or additional inclusions can be found in the material. The SEM images below support the findings of the fatigue behavior.

Figure 16. Microstructural analysis of the Material 2, sample 1 – left charged at HT, right uncharged, three different sections.

In form of a summary, three different charged samples were investigated using SEM analysis. Neither of the charged samples indicate cracks or pores induced by hydrogen, that is, other than already present in the uncharged sample. The hydrogen exposed specimen all show the same microstructural phases and no evidence of hydride formation was found via EDX analysis. Last but not the least, the mass percentage of the material does not change when charging with hydrogen – therefore we can conclude that no hydrides or other forms of inclusions have been formed throughout the process at room temperature and 1000 °C, as seen above.

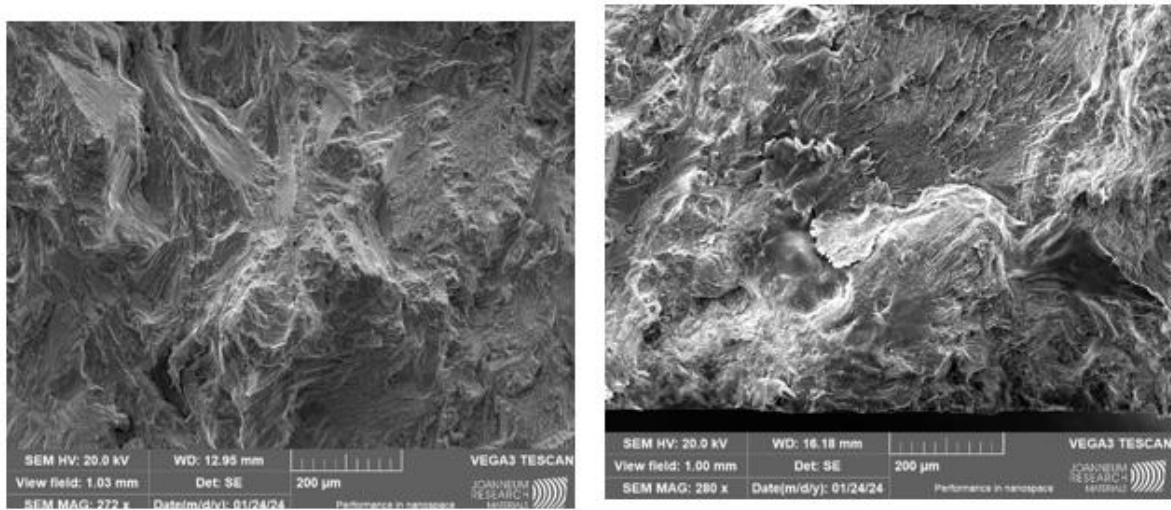
The representative SEM fracture surfaces of Material 1 uncharged vs. 48 h charged at room temperature are presented in the figures below. The pictures represent the fracture surface after failure under maximum stress of 450 MPa.

Figure 17: Fracture surfaces of Material 1 uncharged (right) vs. Material 1 charged at room temperature (left) outer region of sample

All non-hydrogen charged samples show a ductile breaking behaviour. In the inner region of the material, the specimen fractured via ductile micro-void coalescence, indicated by the dimples in this region. No transgranular facets are found in the non-hydrogen charged samples. The hydrogen charged samples display dimples within the inner region. The ductile behaviour of the fracture within the inner region of the material is due to the absence of hydrogen penetration in the bulk of the material. The outer region of the hydrogen charged specimen also display ductile behaviour as no transgranular facets or micro-facet cleavage can be found within the material, indicating an embrittlement of the material. *The absence of slip lines and tear ridges which are referenced to form through the hydrogen penetration<sup>16</sup>, cannot be found within this microstructure.*

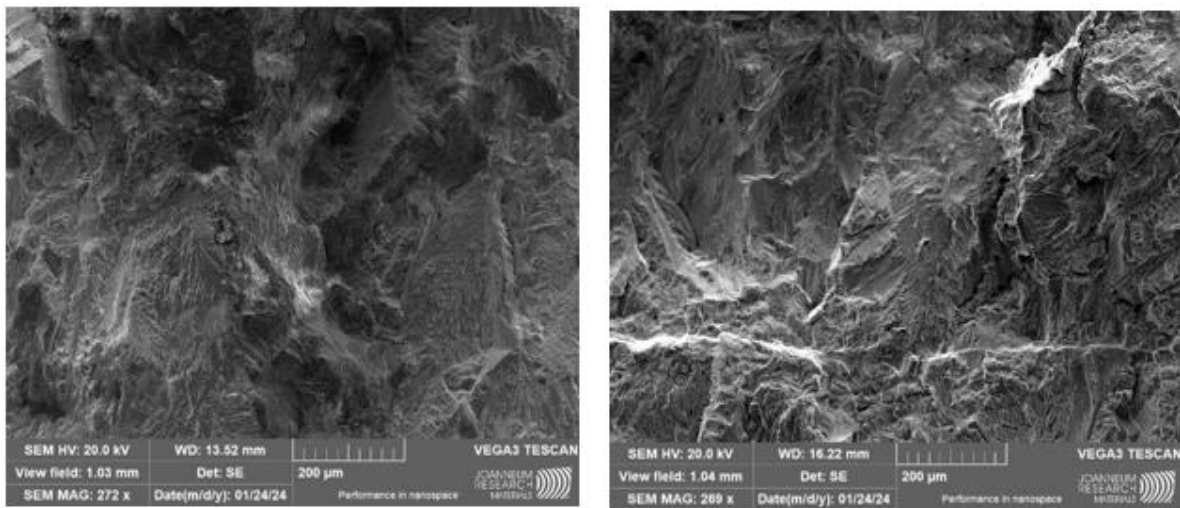
Figure 18: Fracture surfaces of Material 1 uncharged (right) vs. Material 1 charged at room temperature (left) outer region of sample

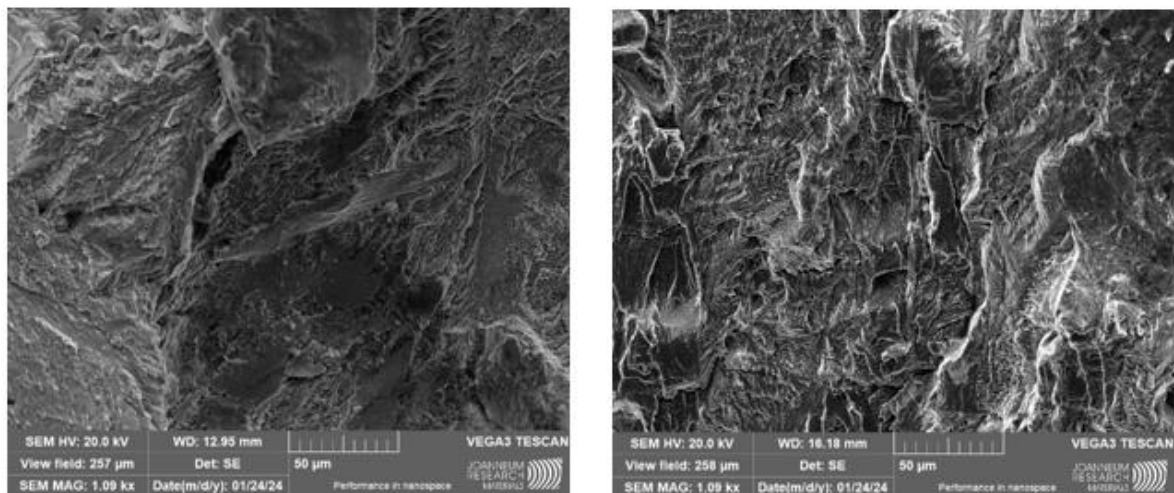
Figure 19: Fracture surfaces of Material 1 uncharged (right) vs. Material 1 charged at room temperature (left) inner region of sample

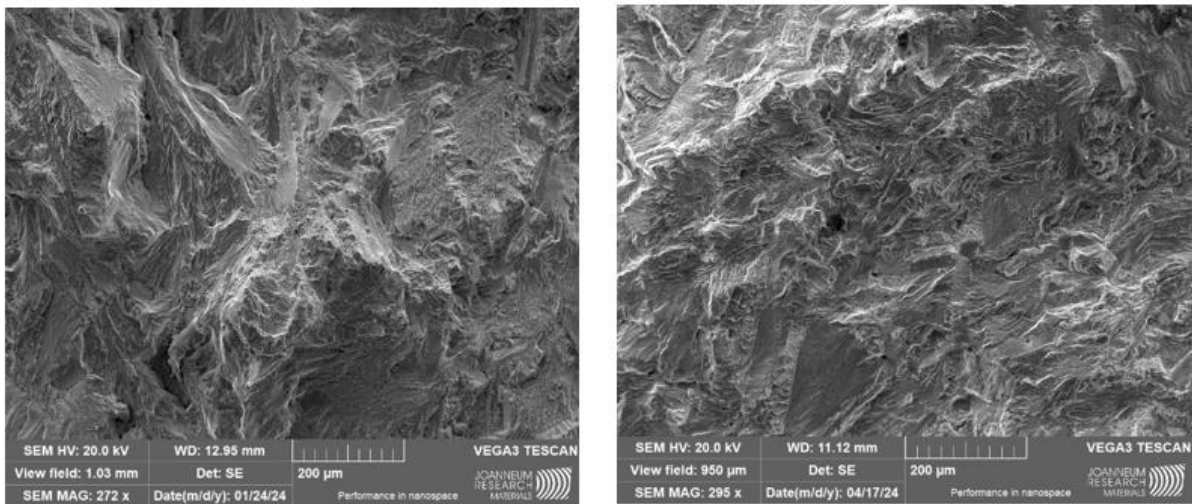
Figure 20: Fracture surfaces of Material 1 uncharged (right) vs. Material 1 charged at high temperature (left) outer region of sample

The fractography of Material 1 at high temperatures indicates that the material was not affected by hydrogen charging. The outer region of the sample indicate intergranular fractures, whereas the inner region of the material displays a more ductile fracture behaviour, as it shows more dimple like behaviour. Even though intergranular fractures can be found in the upper region of the material, where crack nucleation is initiated, this does not change from the uncharged to charged specimen and therefore we can conclude that at elevated temperature up to 1000°C the hydrogen does not brittle the Material 1 alloy.

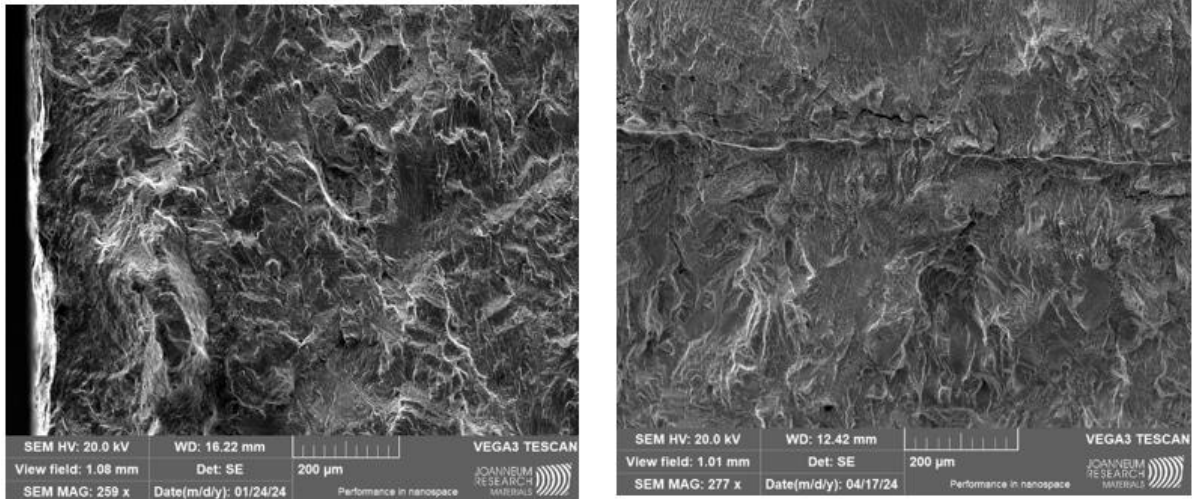
Figure 21: Fracture surfaces of Material 1 uncharged (right) vs. Material 1 charged at high temperature (left) outer region of sample

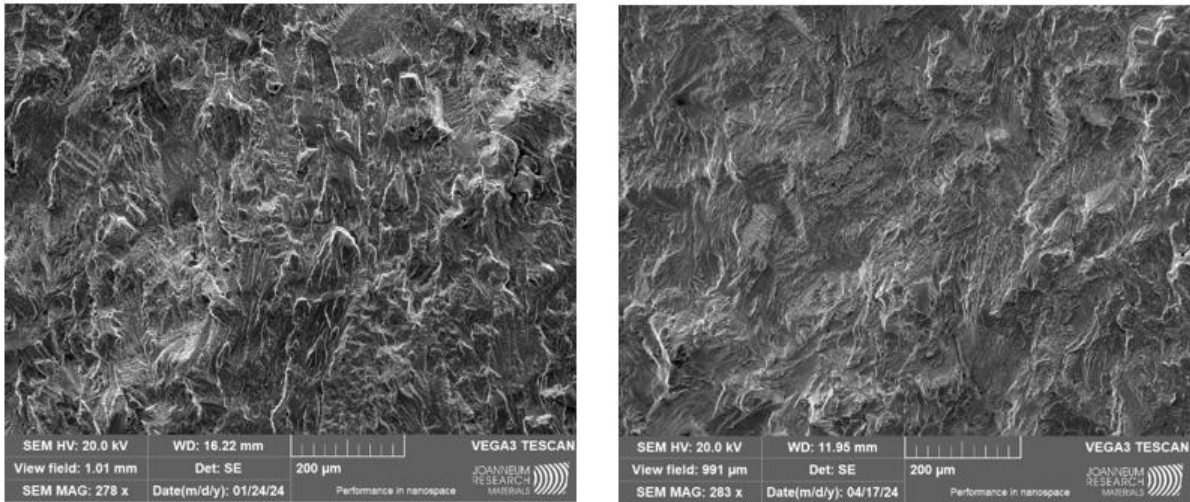
Figure 22: Fracture surfaces of Material 1 uncharged (right) vs. Material 1 charged at high temperature (left) inner region of sample

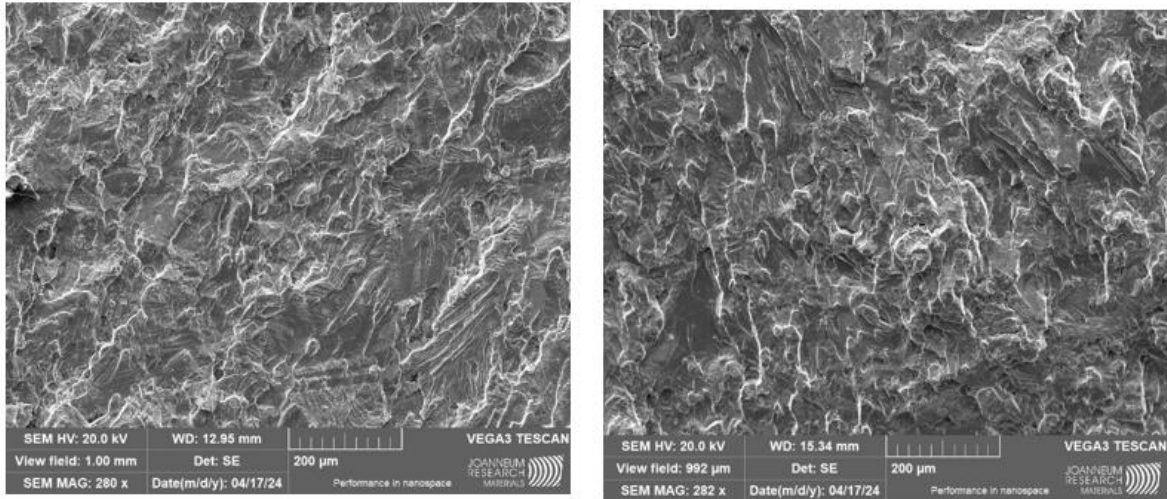
*Figure 23: Fracture surfaces of Material 2 uncharged (left) vs. Material 2 charged at room temperature (right) inner region of sample*

The inner region of the uncharged and room temperature charged material show a very ductile fracture behaviour, due to the dimples, which have also already been explained for the Material 1 fracture behaviour.

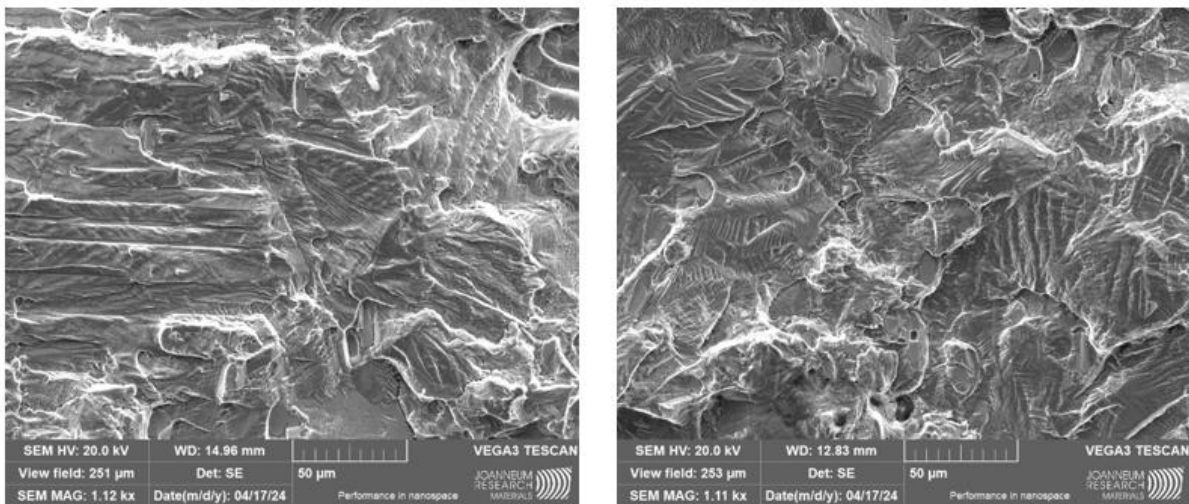
*Figure 24: Fracture surfaces of Material 2 uncharged (left) vs. Material 2 charged at room temperature (right) region of crack initiation of sample*

Within the upper part of the material, where the material starts breaking first, we can observe a more brittle behaviour, as we cannot find as many dimples as in the inner part of the material. But nonetheless, this is the same for the uncharged and charged material and therefore we can conclude that this is due to the breaking mechanism of the material and not caused by hydrogen embrittlement of the material.

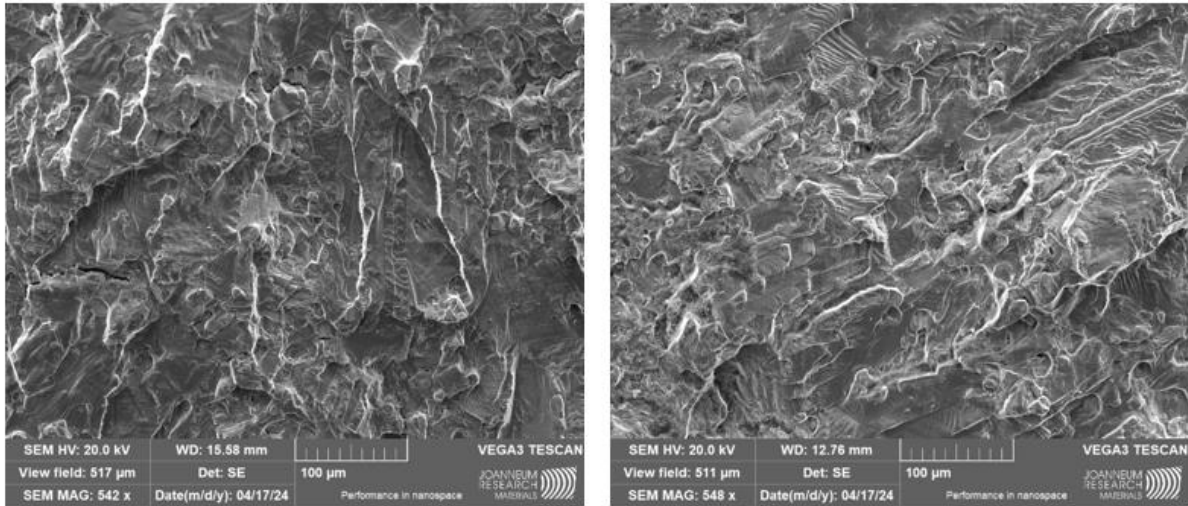
Figure 25: Fracture surfaces of Haynes uncharged (left) vs. Material 2 charged at room temperature (right) outer region of sample

No transgranular facets or micro-facet cleavage can be found in the outer or inner region of the material. Furthermore, the fracture behaviour of the 48h charged sample does not show any changes to the uncharged fracture which is a sign for no hydrogen embrittlement. If hydrogen molecules would have penetrated the material and caused damage, we would observe a brittle fracture, which is not the case.

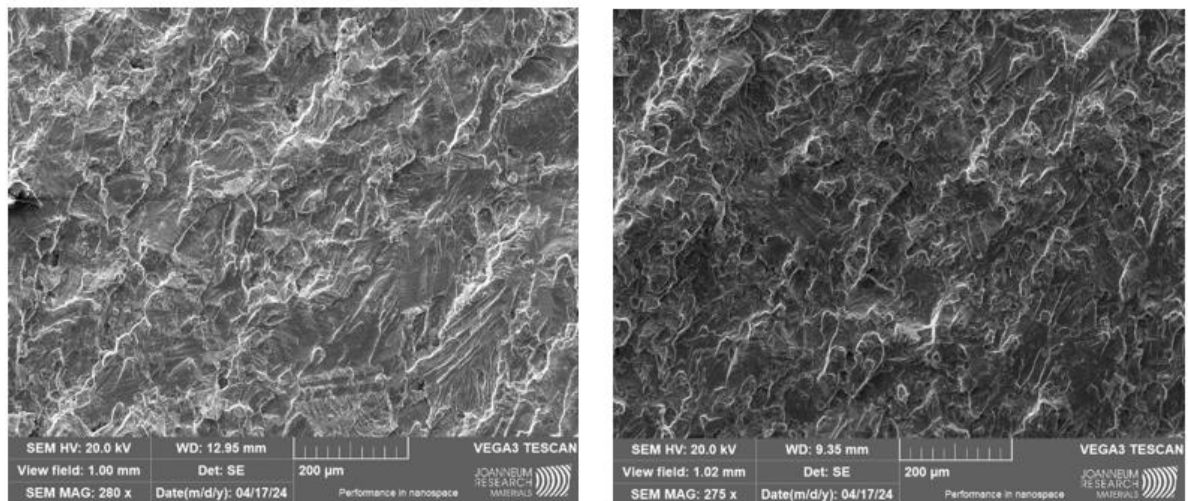
Figure 26: Fracture surfaces of Material 2 uncharged (left) vs. Material 2 charged at high temperature (right) inner region of sample

The inner region of the uncharged and high temperature charged material show a very ductile fracture behaviour, due to the dimples, which have also already been explained for the Material 1 fracture behaviour. Even though the temperature difference was increased by 1000 °C for charging, this did not change the fracture behaviour of the material in the inner region of the material. This means the hydrogen definitely did not affect the bulk of the material.
