# Summary report of tested materials

D1.4

# RecHycle

Oct 2024

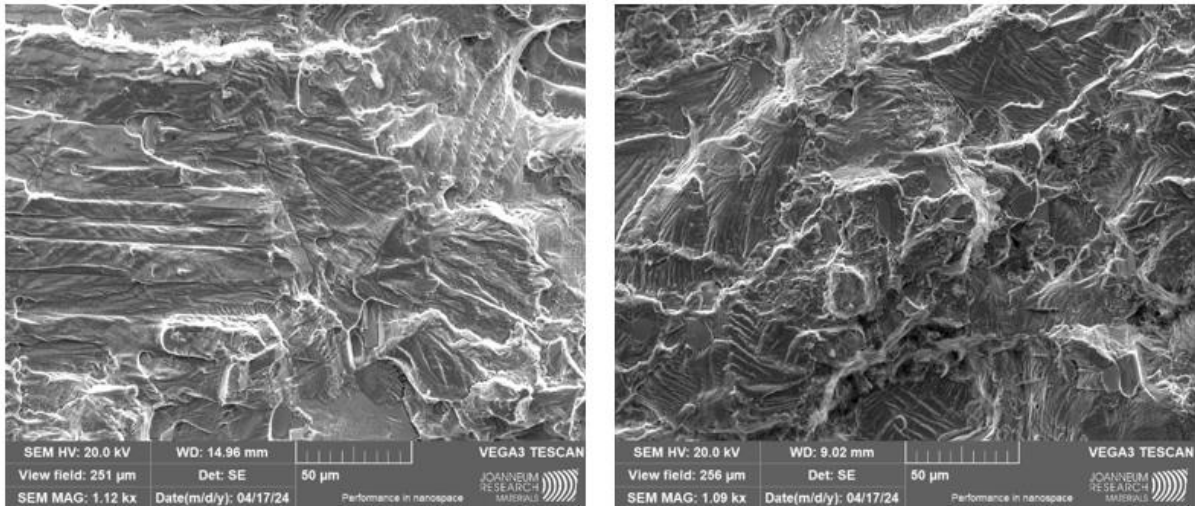
Figure 27: Fracture surfaces of Material 2 uncharged (left) vs. Material 2 charged at high temperature (right) region of crack initiation of sample

We can observe the same phenomena with the high temperature breakage as with the room temperature breakage, which is the following: Within the upper part of the material, where the material starts breaking first, we can observe a more brittle behaviour, as we cannot find as many dimples as in the inner part of the material. But nonetheless, this is the same for the uncharged and charged material and therefore we can conclude that this is due to the breaking mechanism of the material and not caused by hydrogen embrittlement of the material.

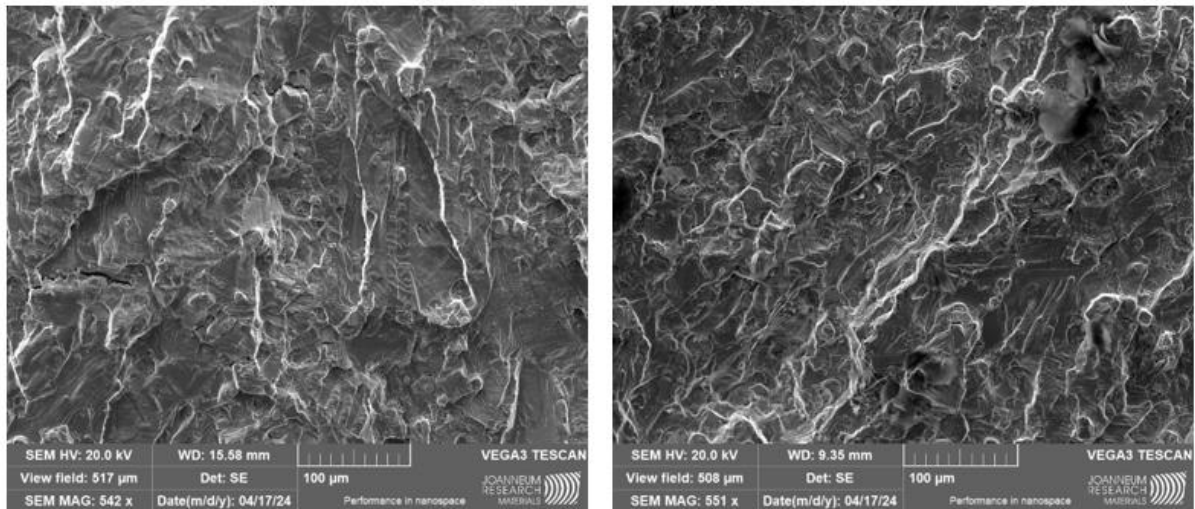
Figure 28: Fracture surfaces of Haynes uncharged (left) vs. Material 2 charged at high temperature (right) outer region of sample
